# Building Inspection Report

## Ellsworth, Maine

3/14/99

***SAMPLE REPORT***

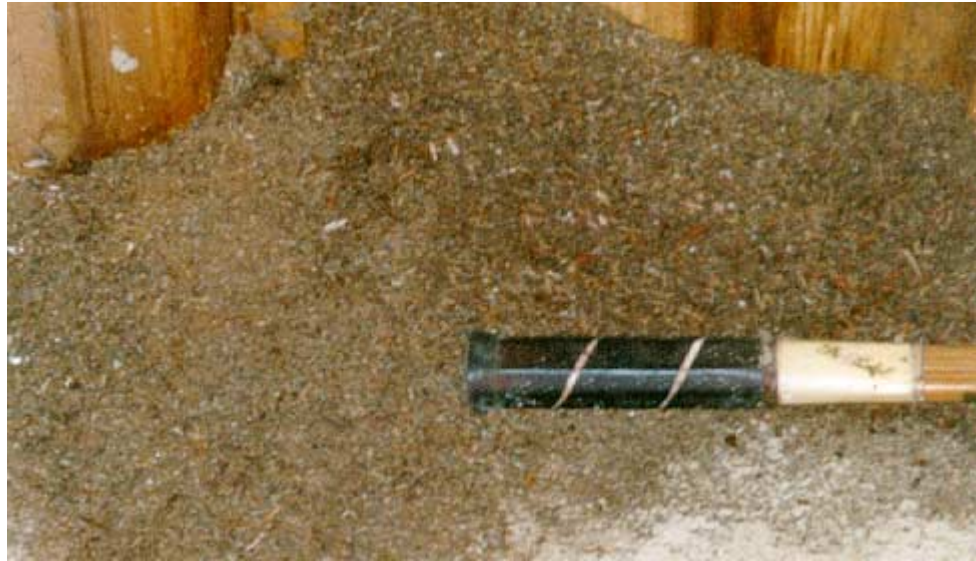
- ☒ Evidence of carpenter ant activity was observed in various locations, however no live insects were seen at the time of inspection. A licensed pest control specialist should be engaged to evaluate this condition and recommend measures to eliminate further carpenter ant activity within the home. (Photo 1)

Evidence of carpenter ant activity.

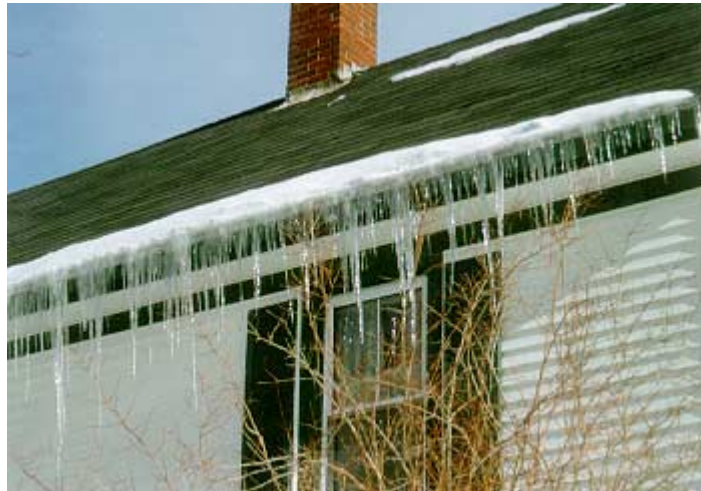
- ☑ **The level of attic ventilation in various locations of the attic is considered marginal.** It is generally recommended that one (1) square foot of free vent area be provided for every one hundred and fifty (150) square feet of ceiling area. Proper ventilation will help to keep the house cooler during warm weather and extend the life of roofing materials. In colder climates, it will help reduce the potential for ice dams on the roof and condensation within the attic. (Photo 2)

Icicles may indicate inadequate attic insulation or limited attic ventilation.
